Contract #: 04-0120F4Cty: SF/ALA Rte: 80 PM: 13.2/13.9File #: 1.28**WELDING INSPECTION REPORT****Resident Engineer:** Casey, William**Address:** 333 Burma Road**City:** Oakland, CA 94607**Report No:** WIR-027071**Date Inspected:** 26-Jan-2012**Project Name:** SAS Superstructure**OSM Arrival Time:** 700**Prime Contractor:** American Bridge/Fluor Enterprises, a JV**OSM Departure Time:** 1530**Contractor:** American Bridge/Fluor Enterprises, a JV**Location:** Job Site**CWI Name:** Bernard Docena**CWI Present:** Yes No**Inspected CWI report:** Yes No N/A**Rod Oven in Use:** Yes No N/A**Electrode to specification:** Yes No N/A**Weld Procedures Followed:** Yes No N/A**Qualified Welders:** Yes No N/A**Verified Joint Fit-up:** Yes No N/A**Approved Drawings:** Yes No N/A**Approved WPS:** Yes No N/A**Delayed / Cancelled:** Yes No N/A**Bridge No:** 34-0006**Component:** Emergency Gates CCO-179**Summary of Items Observed:**

Emergency Gate Installation associated with CCO-179

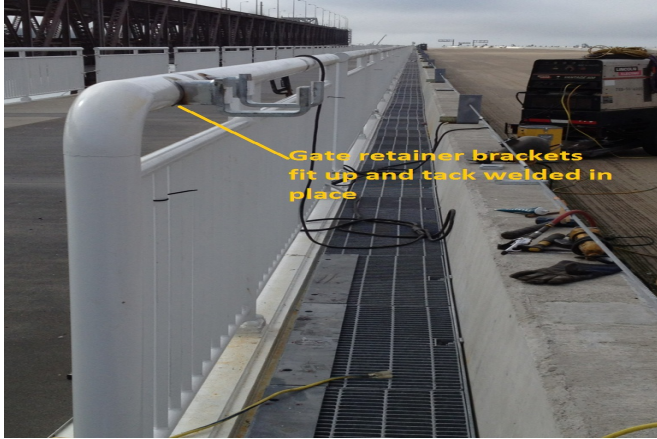
The QA Inspector randomly observed the ABF welder Jason Collins and ABF representatives Bradley Whitburn and Mathew Chamberlin fit up gate retainer, gate latch and stainless steel gate track at the above identified location. The QA Inspector noted the hardware had been previously placed at the location and the paint and galvanized coating had been removed on the existing rail for installation of the emergency gate hardware. The QA Inspector randomly observed the ABF welder fit up and tack weld the gate retainer bracket and gate latch to the existing rail. After they were tack welded in place the gate track was positioned for drilling and tapping the holes for the installation of the stainless steel screws. Once the gate was moving free and clear, the SE QC Inspector performed a visual inspection of the fit up. The QC Inspector informed the QA Inspector the fit up was acceptable. The QA Inspector performed a random visual inspection of the fit up and noted it did appear to be in general compliance with the contract documents for the exception of the stainless steel gate tracks welds.

The QA Inspector observed the ABF welder Jason Collins perform shielded metal arc welding (SMAW) of the restrainer bracket and gate latch for the above identified location. The QA Inspector noted the ABF welder was utilizing 1/8" E7018 low hydrogen electrodes with 122 Amps. The QA Inspector noted the SMAW parameters did appear to be in general compliance with the contract requirements. The QA Inspector noted the ABF personnel did not complete the installation of the above identified emergency gate on this date.
